# Two-year follow-up of a mandibular second premolar with a fractured irrigation needle extending beyond the apex: A case report

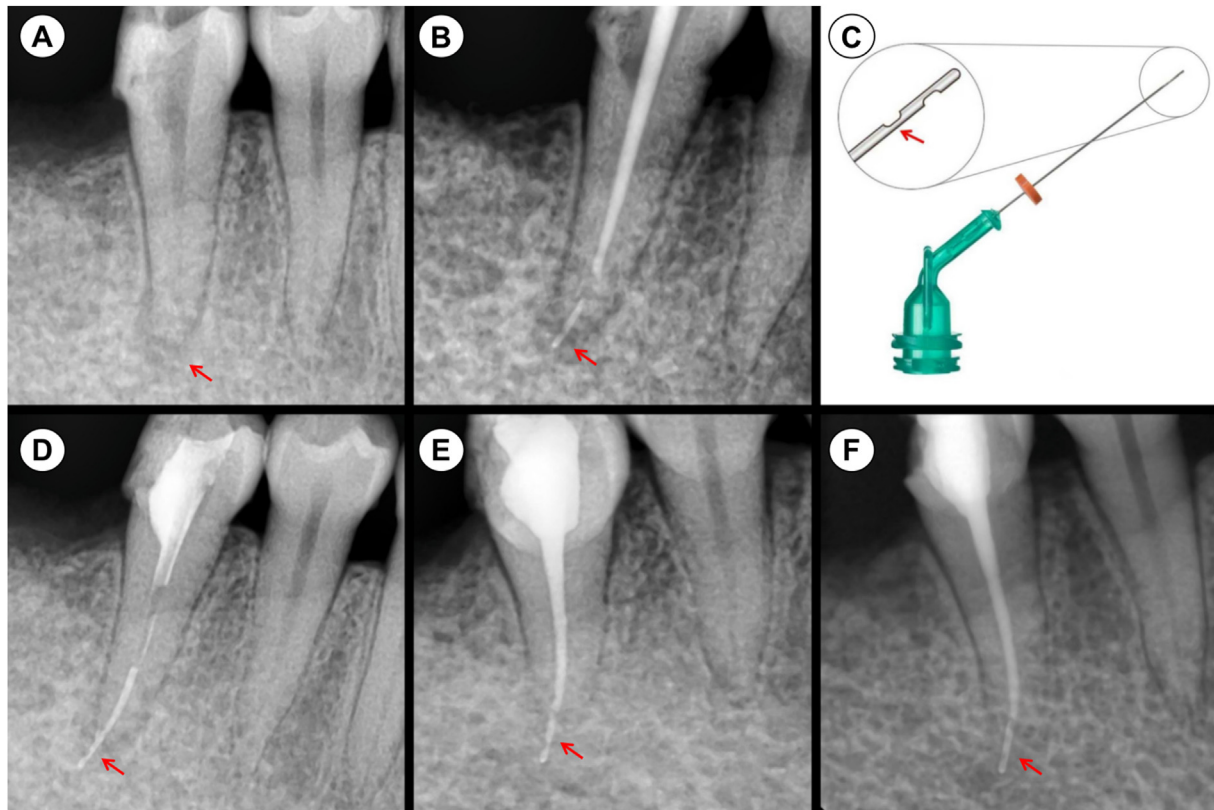
locator. The canal was shaped to #25/.06 using NiTi rotary system, with alternating irrigation using a 31G/27 mm double side-vented irrigation needle with 3 % NaOCl and 17 % ethylenediaminetetraacetic acid (EDTA) solution. Calcium hydroxide paste was introduced into the canal, and the access cavity was sealed with a temporary filling material. One week later, the patient returned. The tooth was re-isolated, and the temporary filling removed. The canals were rinsed with a 31G/27 mm double side-vented irrigation needle and 3 % NaOCl solution. A trial fitting of the master gutta-percha cone revealed a radiopaque fragment in the apex (Fig. 1B). The shape suggested it was the tip of the irrigation needle, confirming an instrument fracture (Fig. 1C). The patient was informed of the fracture and presented with two options: complete the root canal treatment without removing the fractured instrument or opt for surgical intervention. Choosing the former, the canal was soaked in 3 % NaOCl solution and underwent three 20-s ultrasonic irrigation sessions with an ultrasonic tip followed by 17 % EDTA solution. The root canal filling was completed using the continuous wave obturation technique, and a periapical radiograph was taken to confirm good apical sealing (Fig. 1D), and the canal was backfilled with gutta-percha. The restoration was completed with a light-cured composite resin. The patient was advised to observe for two weeks before proceeding with the post-and-core supported full crown restoration. At

**Figure 1** Periapical radiographs of our case of the mandibular second premolar and schematic diagram of the double side-vented irrigation needle. (A) Pre-operative radiograph showing a periapical lesion of the tooth #45 (red arrow). (B) Radiograph of master gutta-percha cone fitting revealing a radiopaque fragment (red arrow) in the root apex. (C) Schematic diagram of a 31G/27 mm double side-vented irrigation needle. The red arrow indicates the needle's weak point and the location of the fracture. (D) Periapical radiograph demonstrating good apical sealing of the fractured irrigation needle fragment (red arrow). (E) Six-month follow-up radiograph revealing complete healing of the periapical lesion of the tooth #45 (red arrow). (F) Two-year follow-up radiograph displaying normal lamina dura around the root apex of the tooth #45 (red arrow).

the 6-month follow-up, the tooth remained asymptomatic. A periapical radiograph showed complete healing of the periapical lesion (Fig. 1E). At the two-year follow-up, the tooth was still asymptomatic, and a radiograph showed normal lamina dura around the apex (Fig. 1F).
