# Microsurgical removal of an invisible fractured endodontic instrument from a mandibular first molar

Endodontic  
microsurgery;  
Fractured instrument  
removal;  
Molar tooth

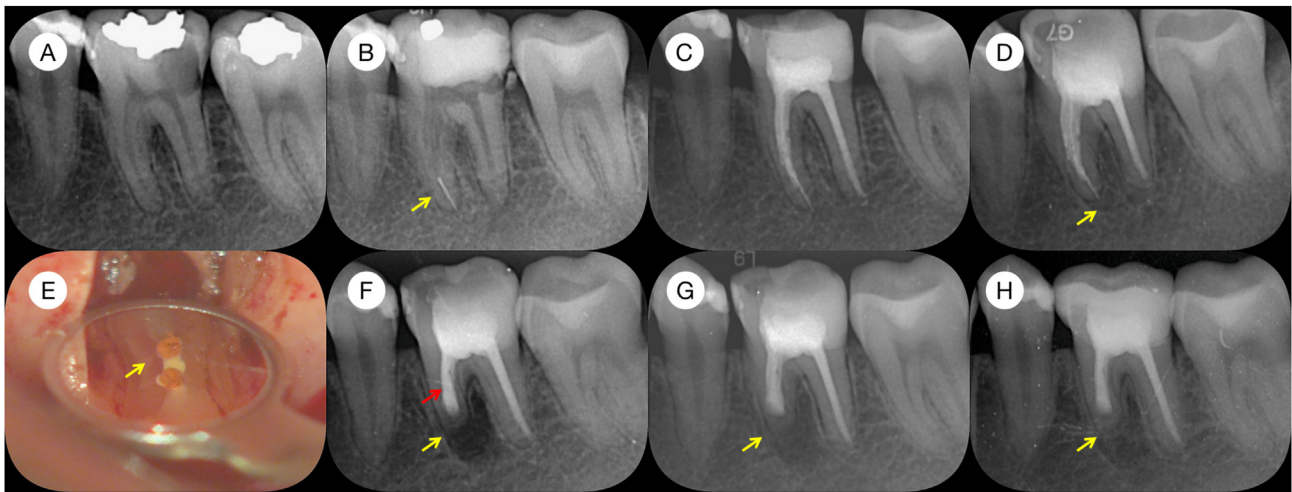
**Figure 1** Microscopic photographs and radiological images of tooth #36. (A) Periapical radiograph exhibited that the tooth had an amalgam restoration, a substantial caries lesion affecting the pulp chamber and a slightly widened periodontal ligament space in the periapical area; (B) Periapical radiograph revealed that there was a fractured instrument in the apical part of the mesial root (yellow arrow); (C) Periapical radiograph showed that the tooth underwent root canal obturation followed by the restoration of the tooth using composite resin material; (D) Periapical radiograph exhibited a minor radiolucent area in the periapical region of the mesial root (yellow arrow); (E) Microscopic photograph showed that resection surface of the mesial root (yellow arrow); (F) Periapical radiograph revealed the complete removal of the fractured instrument (yellow arrow) and the obturation of the retrograde cavity with bioceramic material (red arrow); (G) Periapical radiograph at the 3-month follow-up revealed the reduction in the periapical lesion of the mesial root (yellow arrow); (H) Periapical radiograph at the 24-month follow-up displayed normal lamina in the periapical area of the mesial root (yellow arrow).

A 24-year-old female patient presented with the chief complaint of spontaneous pain in tooth #36 for two weeks. The tooth exhibited heightened sensitivity when subjected to a cold pulp test and was accompanied by persistent, severe pain. Periapical radiograph displayed that tooth #36 had an amalgam restoration and a substantial caries lesion affecting the pulp chamber (Fig. 1A). Tooth #36 was diagnosed with symptomatic irreversible pulpitis. Root canal treatment was proposed, and the patient provided written informed consent. The procedure was undertaken by a resident student. Unfortunately, while conducting root canal preparation, there was an incident of fracture involving a nickel titanium rotary instrument in the apical region of the mesial root of tooth #36 (Fig. 1B). Attempts to remove the fractured instrument via nonsurgical means

proved unsuccessful. The patient was informed the occurrence of instrument fracture, and two options were presented for consideration: performing root canal obturation without removing the fractured instrument or undergoing surgical intervention. Opting for the former, the patient's choice prompted the completion of the root canal treatment, culminating in the restoration of the tooth with composite resin material (Fig. 1C).

During the 6-month follow-up examination, the patient reported chewing pain in tooth #36. The tooth had tenderness to percussion. Periapical radiograph exhibited a minor radiolucent area in the periapical region of the mesial root of tooth #36 (Fig. 1D). Tooth #36 was diagnosed with symptomatic apical periodontitis. Endodontic microsurgery was recommended, and the patient provided written informed consent. Under local infiltration anesthesia, a triangular mucoperiosteal flap was elevated. Subsequently, the apical part of the mesial root was exposed, and a diamond bur was employed to resect the apical root portion containing the fractured instrument. The resection surface was scrutinized using the operating microscope to confirm the complete removal of the fractured instrument (Fig. 1E). A 3-mm retrograde cavity was created using an ultrasonic tip and subsequently filled with bioceramic material. Following the closure of the surgical flap using sutures, a postoperative radiograph was obtained (Fig. 1F). After one week, the sutures were removed, and tooth #36 exhibited no symptom. At the 3-month follow-up, the tooth remained

asymptomatic and there was evident reduction in the periapical lesion of the mesial root (Fig. 1G). The tooth was then restored with a ceramic crown. At the 24-month follow-up, tooth #36 remained asymptomatic, with normal lamina dura in the periapical area of the mesial root (Fig. 1H).
