## Original Article

# Surface strain at the cervical area and fracture strength of flared root canals reinforced using a zirconia tube and glass-fiber post

**Abstract** *Background/purpose:* Recently, an effective core build-up system for teeth with flared root canals is needed. This research aimed to evaluate the effect of foundation restorations using a composite resin core with a fiber post reinforced with a zirconia tube for the surface strain at the cervical area and the fracture load of teeth with flared root canals.

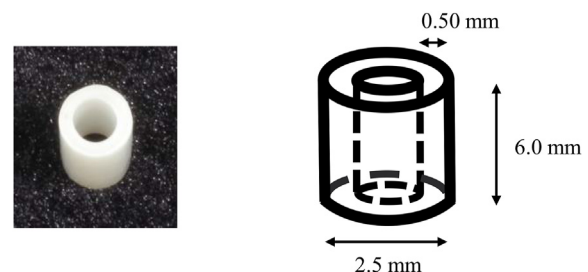
Figure 1 The shape of a prefabricated zirconia tube.

Zirconia tubes (diameter, 2.5 mm; height, 6 mm; and thickness, 0.5 mm) prepared from zirconia discs (Katana HTML, Kuraray Noritake Dental Inc., Tokyo, Japan) were used in this study (Fig. 1).

The zirconia tube used in this experiment was fabricated using 3Y-TZP zirconia, which is the same material used for fabricating crowns. As the minimum thickness required to fabricate a crown using 3Y-TZP zirconia is 0.5 mm,<sup>34</sup> the thickness of the zirconia tube was set as 0.5 mm. The height of the zirconia tube was set as 6 mm to allow for the same length of insertion into the core and root, according to the 3 mm insertion of the fiber post into the core in a previous study.<sup>24,27</sup>

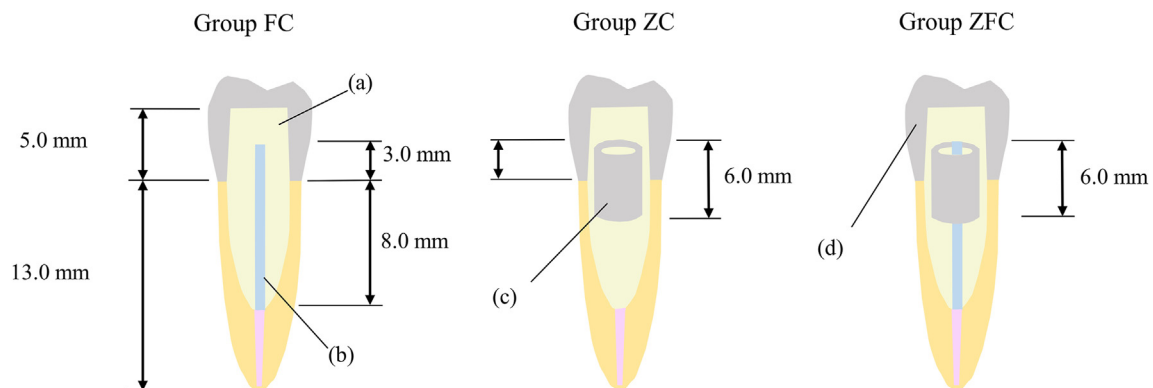
**Figure 2** The experimental groups. FC: composite resin core with prefabricated fiber post, ZC: composite resin core with a prefabricated zirconia tube, ZFC: composite resin core with a prefabricated zirconia tube and prefabricated fiber post. (a) Composite resin, (b) Prefabricated glass-fiber post, (c) Prefabricated zirconia tube, (d) and Monolithic zirconia crown.

Three different core build-up systems were tested in this study: a composite resin core and a glass-fiber post (FC), a composite resin core and a zirconia tube (ZC), and a composite resin core along with a zirconia tube and a glass-fiber post (ZFC). Eight specimens were allocated to each group

for each test as described in previous studies.<sup>2,23</sup> In the previous study, the mean and standard deviation measured in the pilot study were used to calculate effect sizes and determine sample sizes.<sup>23</sup> Impressions of the post space of the specimens were made using a silicone impression material (Examixfine regular type and Exafine putty type, GC Co.), and a dental plaster cast was fabricated from the dental stone (New Fujirock, GC Co.). A core pattern was waxed up on the plaster cast, and an impression was made using an additional reactive silicone impression material (MEMOSIL2, Heraeus Kulzer, Hanau, Germany) to create a mold of the core pattern. The abutment height was adjusted to 5 mm. The surfaces of the experimental roots were cleaned with distilled water and air-dried. A bonding agent (Clearfil Universal Bond Quick ER, Kuraray Noritake Dental Inc.) was applied for 10 s and spread over the entire post space using a low-pressure air blow. The excess bonding agent was removed using paper points and air blow. The surfaces of the post spaces were cured for 20 s using a light-curing unit (Blueshot, Shofu Inc.), which emitted light at an intensity of 650 mW/cm<sup>2</sup> (Fig. 2).

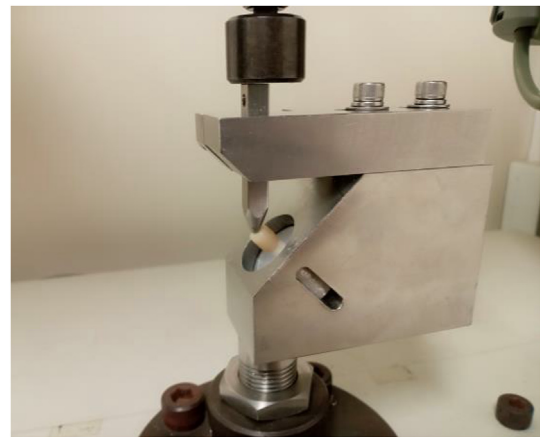
Figure 4 Experimental set up for the fracture test.

The fracture loads of the specimens were measured as described below. Loads were applied to the inner slope of the buccal cusp at 45° to the long axis of the tooth using the universal testing machine (Autograph AGS-H, Shimadzu Co.) at a crosshead speed of 1.0 mm/min to measure the maximum load at failure (Fig. 4). The load with 45° direction simulated the oblique load applied to the teeth during

masticatory function.<sup>32</sup> The reason for applying the oblique load was that oblique load provides higher strain at the cervical surface area than axial load.<sup>32</sup>

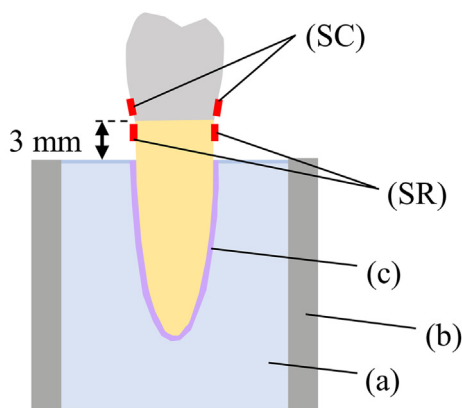
Figure 3 Schematic representation of the embedded experimental specimens. (a) Acrylic resin, (b) Aluminum ring, (c) Vinyl polysiloxane impression material, (SC) Strain gauge attached to crown, and (SR) Strain gauge attached to root.

Four strain gauges (KFRB-02N-120-C1-16 N30C2; Kyowa Electronic Instruments Co., Ltd., Tokyo, Japan) were adhered to the crowns and roots immediately above and below the margin on the buccal and lingual sides to measure the surface strain in the cervical area (Fig. 3). It is because when single-root teeth were subjected to a load applied at 45° angle to the long axis, it was reported that the greatest compressive and tensile stresses occur at the lingual or buccal surface of the cervical area.<sup>30</sup> The adhered surfaces were sandblasted at 0.2 MPa using 70 µm alumina maintaining the distance of 10 mm for 5 s. A strain gauge cement (CC-33A, Kyowa Electronic Instruments Co., Ltd.) was applied to the bonding surfaces, and the strain gauges were held for 1 min under finger pressure. The samples were stored for 24 h at room temperature. The roots of the samples were embedded into acrylic resin (Palapress vario; Heraeus Kulzer.) up to 3 mm below the margin. The roots were surrounded with a vinyl polysiloxane material (Correct Quick, Pentron Co., Wallingford, CT, USA) which has a thickness of 0.25 mm to simulate the periodontal ligament. Loads were applied at 45° to the long axis with a universal testing machine (Autograph AGS-H, Shimadzu Co., Kyoto, Japan) at a crosshead speed of 1.0 mm/min up to 50 N using a ball end with a diameter of 2 mm. The loading point was the inner slope of the buccal cusp. The strain in the buccolingual cervical area was also measured. The data obtained were corrected using the gauge rate. It was reported that the mean human masticatory force is approximately 50 N.<sup>31</sup> The magnitude of the load was set within the range of the loads applied to the premolars during masticatory function.<sup>32</sup>

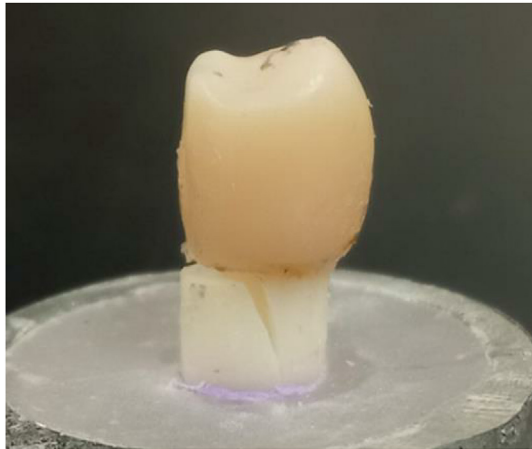
**Figure 5** A photograph of the fractured specimen.

Table 1 shows the mean values and standard distributions of the surface strains. One-way ANOVA revealed a significant difference in the surface strains on the buccal aspect of the root ( $F = 17.8$ ,  $P < 0.001$ ). Tukey's HSD test revealed that the surface strains on the buccal aspect of the root in Groups ZFC and ZC were significantly lower than that in Group FC ( $P < 0.001$ ). One-way ANOVA revealed significant intergroup differences in fracture strength ( $F = 14.9$ ,  $P < 0.001$ ). Tukey's HSD test revealed that the mean (standard deviation) fracture strengths of Groups ZFC [1286 (195) N] and ZC [1013(219) N] were significantly higher than that of Group FC [777(135) N] ( $P < 0.05$ ). In addition, it was observed that the strength of Group ZFC was significantly higher than that of Group ZC ( $P = 0.021$ ). However, irreparable vertical root fractures extending below the alveolar bone margin were observed in all specimens (Fig. 5).
